ROOFS IN BARE 55% Al-Zn COATED STEEL

55% Al-Zn THE MAGIC FORMULA FOR ROOFS

This comprehensive field inspection report shows that even in low-pitch standing seam roofs it has a life expectancy of well over 40 years.

This report covers surveys of established roofs in unpainted 55% Al-Zn in both the USA and Europe. Roofs examined were mainly in urban, industrial, marine and acid rain environments, and ranged in age from 9 to 30 years. Most had a slope of less than 10 degrees (1 degree = 1/4:12).

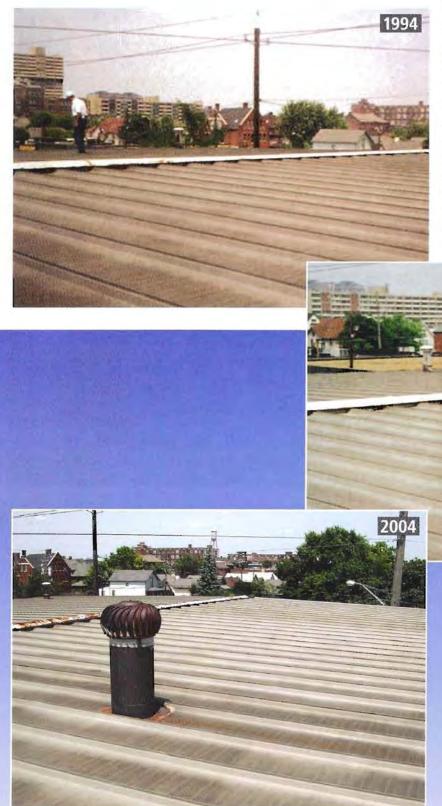
The deterioration of the galvanized accessories is obvious, but the 55% Al-Zn sheets are virtually like new, except for a cosmetic reduction of the surface shine through dirt accumulation and natural oxidation. There has been very little change since the 1994 survey: indeed, very little change since the roof was first built – despite the acid rain environment of Indianapolis.

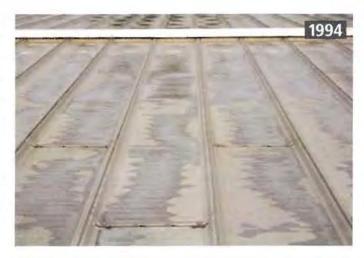
Location:	Appleton, Wisconsin, USA
Environment:	Industrial (Paper Mill)
Slope:	1 degree
Age:	31 years

Nearby paper mills make this an aggressive environment, but despite being more than 30 years old, the 55% AI-Zn coating remains intact and continues to protect the roof sheets from corrosion. This roof looks set to last another 10 years without major maintenance.

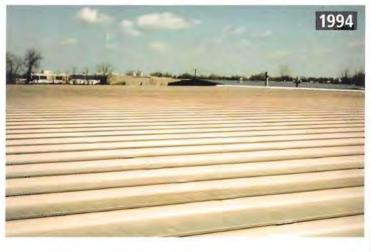
Location:	Appleton, Wisconsin, USA
Environment:	Industrial
Slope:	1 degree
Age:	30 years

The main picture confirms the good condition of this roof, technically and aesthetically. Picture A demonstrates that the roof has to accommodate a number of ancillary structures, some showing advanced deterioration. Picture B shows that there is only minimal damage around fastenings and at the drip edge.

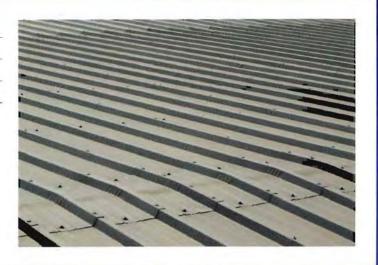
Dirt has affected the cosmetic appearance of this roof after 30 years, but there is no damage to the coating which continues to perform well.

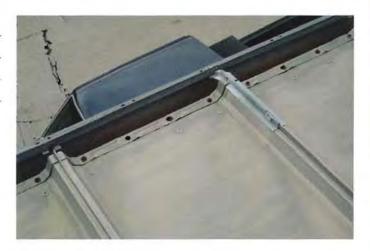
Location:	Indianapolis, Indiana, USA
Environment:	Urban
Slope:	1 degree
Age:	30 years

Again, the drip edge is clean and corrosion-free after 30 years' service. The 55% Al-Zn roof sheets continue to perform, although accessories in galvanized steel display significant red rust.

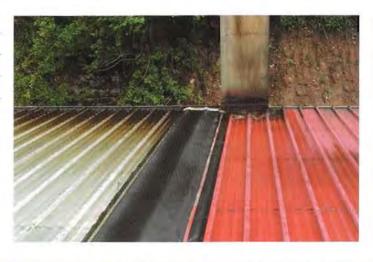
Location:	Vecoux, France	
Environment:	Rural	
Slope:	20 degrees	
Age:	17 years

The post-painted (field-painted) hot dip galvanized roof section is in poor condition, and even perforated at a few points. The 55% Al-Zn section, though dirty, is in good condition – apart from localized corrosion due to pollution from the roof stack.

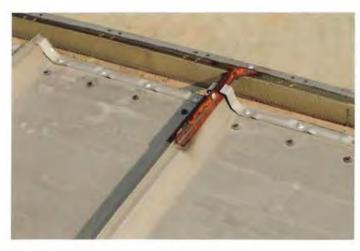
Location:	Appleton, Wisconsin, USA
Environment:	Industrial
Slope:	1 degree
Age:	30 years

The galvanized hanger is at an advanced stage of rusting, but the 55% Al-Zn sheets are in excellent condition.

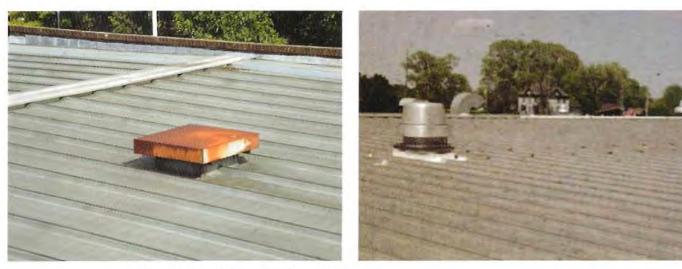
Location:	Cambridgeshire, UK (left) and Indiana, USA (right)
Environment:	Industrial (UK) and industrial acid rain (USA)
Slope:	<5 degrees (UK) and 2 degrees (USA)
Age:	22 years (UK) and 25 years (USA)

Terminal rusting is clear on the galvanized roof vents in both these applications, but the roofing sheets in 55% Al-Zn remain in excellent condition, despite harsh environments.

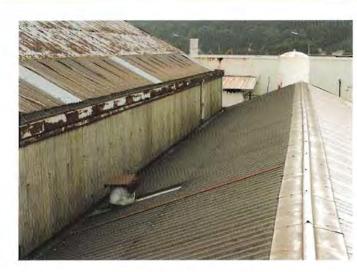
Location:	Flemalle, Belgium	
Environment:	Heavy industrial	
Slope:	10 degrees	
Age:	26 years

Installed in 1977, the 55% Al-Zn steel roof in the centre of the main picture is very dirty, but despite 26 years in a highly aggressive environment it is still in good condition. A section of the 55% Al-Zn roof abuts on to another profiled section in pre-painted hot dip galvanized steel, and is also bordered by unpainted hot-dip galvanized. If ever a picture were worth a thousand words, this is it: the superior performance of 55% Al-Zn is obvious.

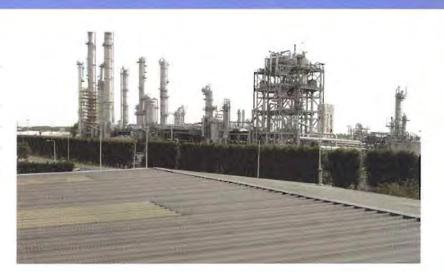
Location:	Rotterdam, The Netherlands	
Environment:	Heavy industrial/ light marine	
Slope:	7 degrees	
Age:	18 years	
		-

Chemical operations immediately adjacent to a cement factory, and the sea a couple of miles away... a particularly punishing environment. Yet after 18 years the roof in 55% Al-Zn looks as good as new.

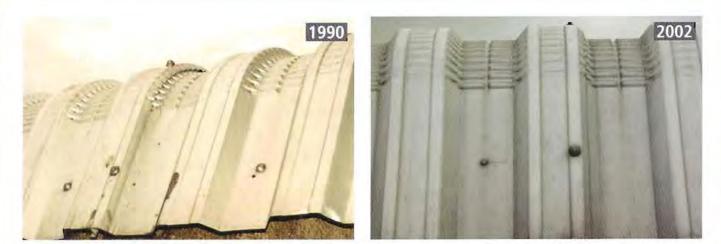
Location:	Cumbria, UK
Environment:	Rural
Slope:	Curved section
Age:	18 years

Not surprisingly, the rural environment of this UK factory has helped the 55% Al-Zn roof sheets to achieve outstanding performance. Even on a potentially troublesome curved section, 55% Al-Zn is still performing well – only a slight black staining has occurred since the picture on the left was taken in 1990. The picture on the right was taken 12 years later.

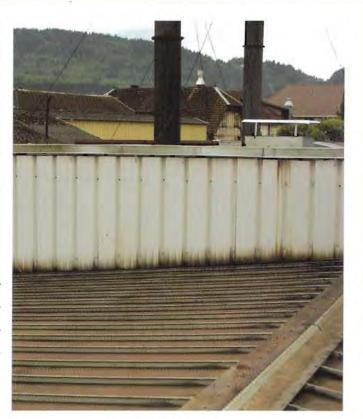
Poor material choice for adjacent chimneys. In the left hand picture, the use of weathering steel for the chimney in the background has caused minor pitting corrosion to the 55% Al-Zn roof after 20 years; copper ions from the chimney material, swept down by rain, will continue to attack and damage the roof. On the right, the weathering steel chimneys have caused some corrosion, but there is so far no perforation of the coating. These problems could have been avoided if the recommended design parameters had been observed.
