ROOFS IN BARE 55% Al-Zn COATED STEEL

55% Al-Zn THE MAGIC FORMULA FOR ROOFS

This comprehensive field inspection report shows that even in low-pitch standing seam roofs it has a life expectancy of well over 40 years.

This report covers surveys of established roofs in unpainted 55% Al-Zn in both the USA and Europe. Roofs examined were mainly in urban, industrial, marine and acid rain environments, and ranged in age from 9 to 30 years. Most had a slope of less than 10 degrees (1 degree = 1/4:12).

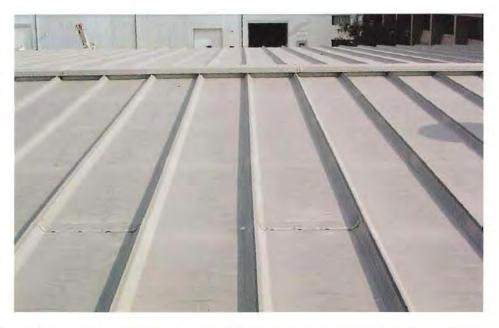
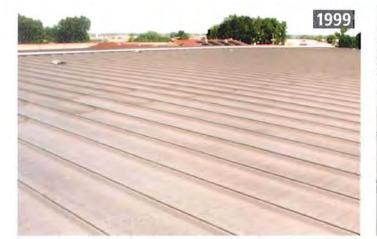
Nearby paper mills make this an aggressive environment, but despite being more than 30 years old, the 55% AI-Zn coating remains intact and continues to protect the roof sheets from corrosion. This roof looks set to last another 10 years without major maintenance.

Location:	Appleton, Wisconsin, USA
Environment:	Industrial
Slope:	1 degree
Age:	30 years

The main picture confirms the good condition of this roof, technically and aesthetically. Picture A demonstrates that the roof has to accommodate a number of ancillary structures, some showing advanced deterioration. Picture B shows that there is only minimal damage around fastenings and at the drip edge.
