**Digiscan**  ™

From Deck to Cloud:  
Leak Detection Scanning  
for Inverted Roofs

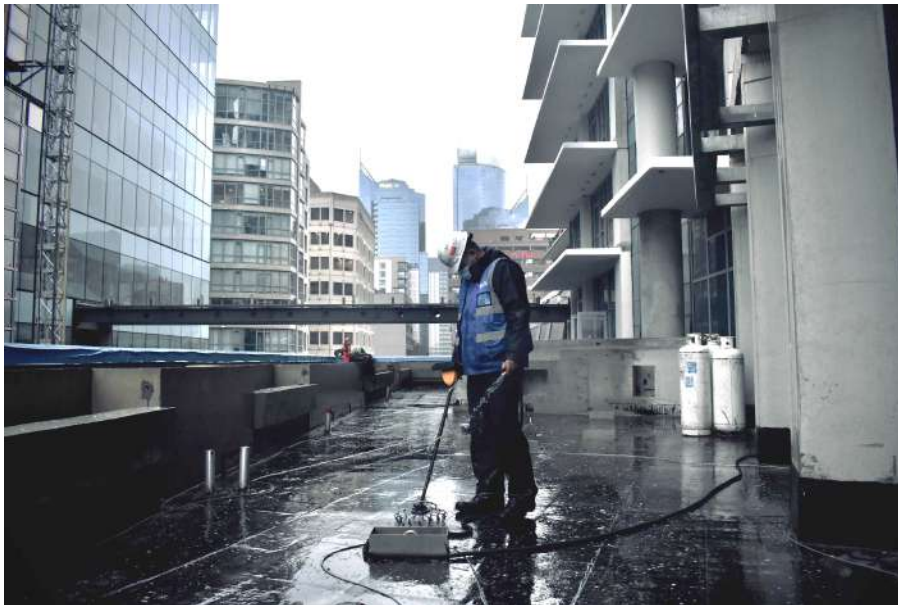
*Above: An SMT Technician performs a Digiscan service on an inverted roof membrane*

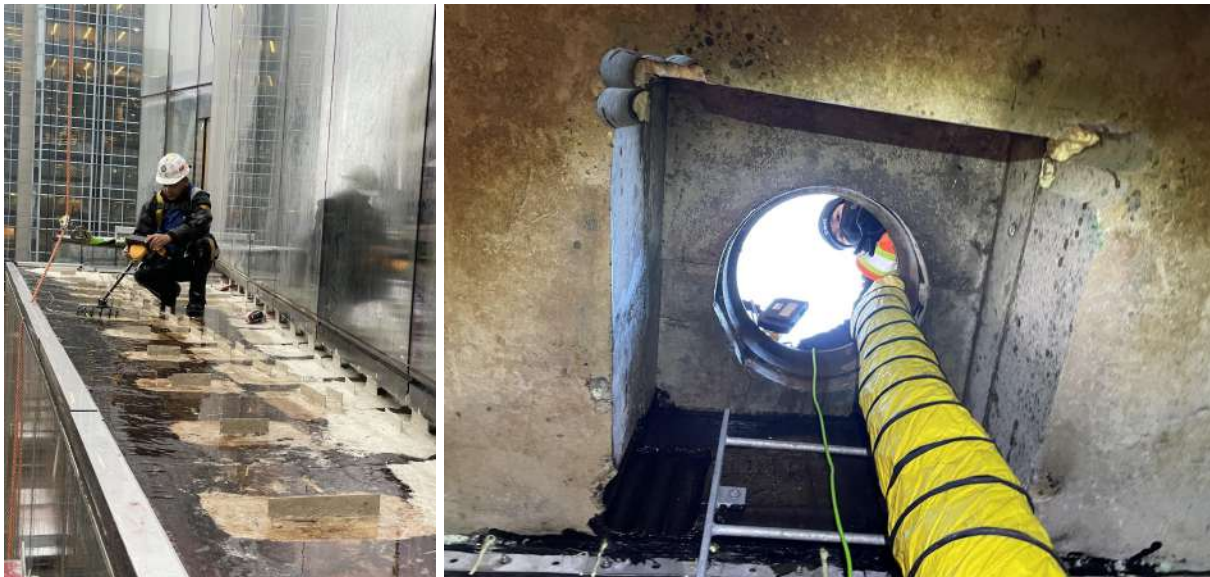
*Above Left: SMT Technician uses a harness to scan a high-up ledge.*

*Above Right: Digiscan Services can be used to check the waterproofing inside tanks and cisterns.*

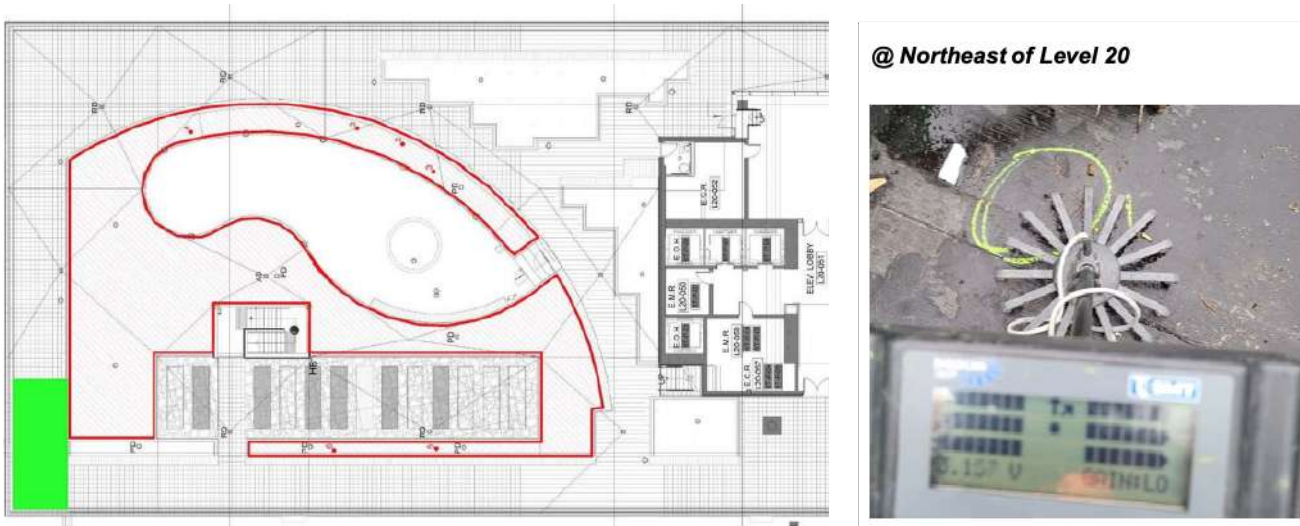
Above: Deficiencies found are plotted on CAD drawings to assist with any further repairs, and as a historical record. Photographs of each deficiency are also included.

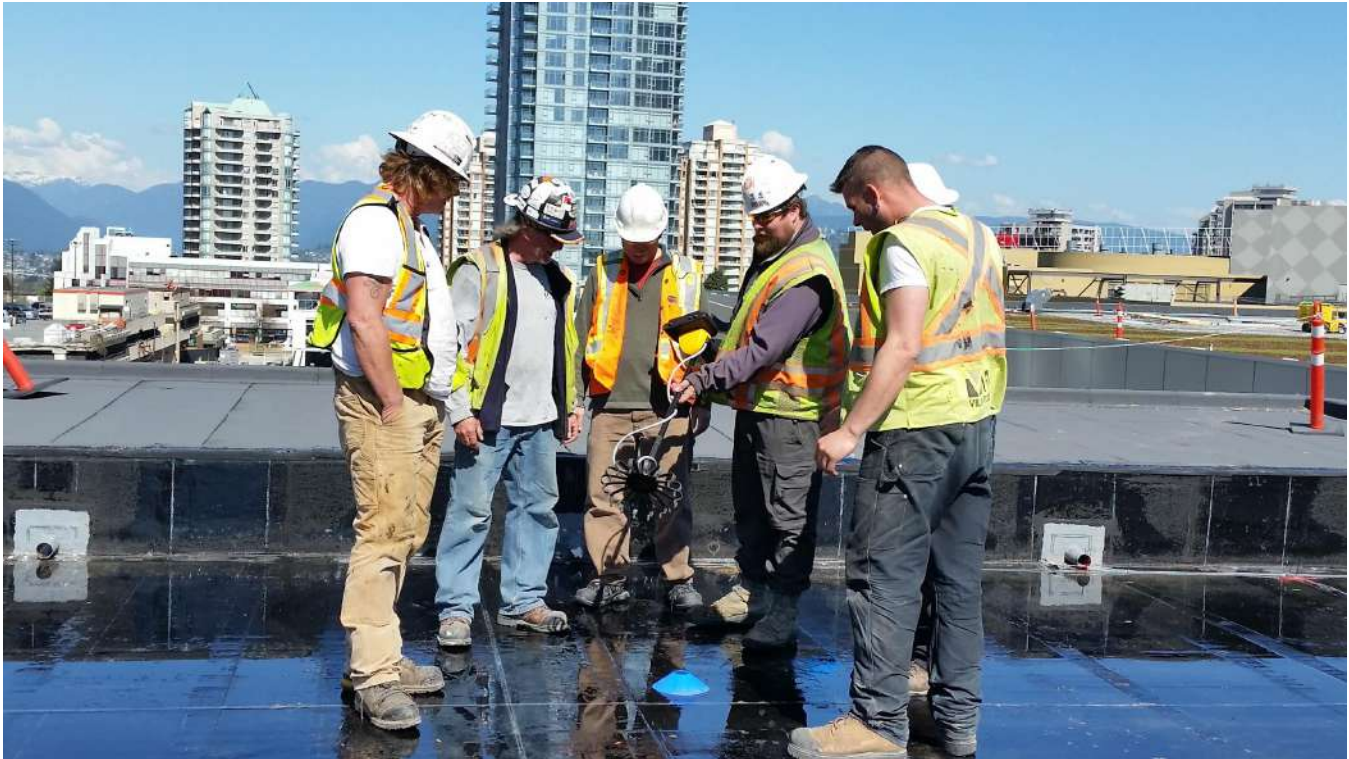
*Above: An SMT Technician provides training with a Digiscan 360.*
